**January 26, 2026**

## **Recent Investigations of Water Quality in Letts Creek**

**Steven J. Wright, PhD, P.E.**

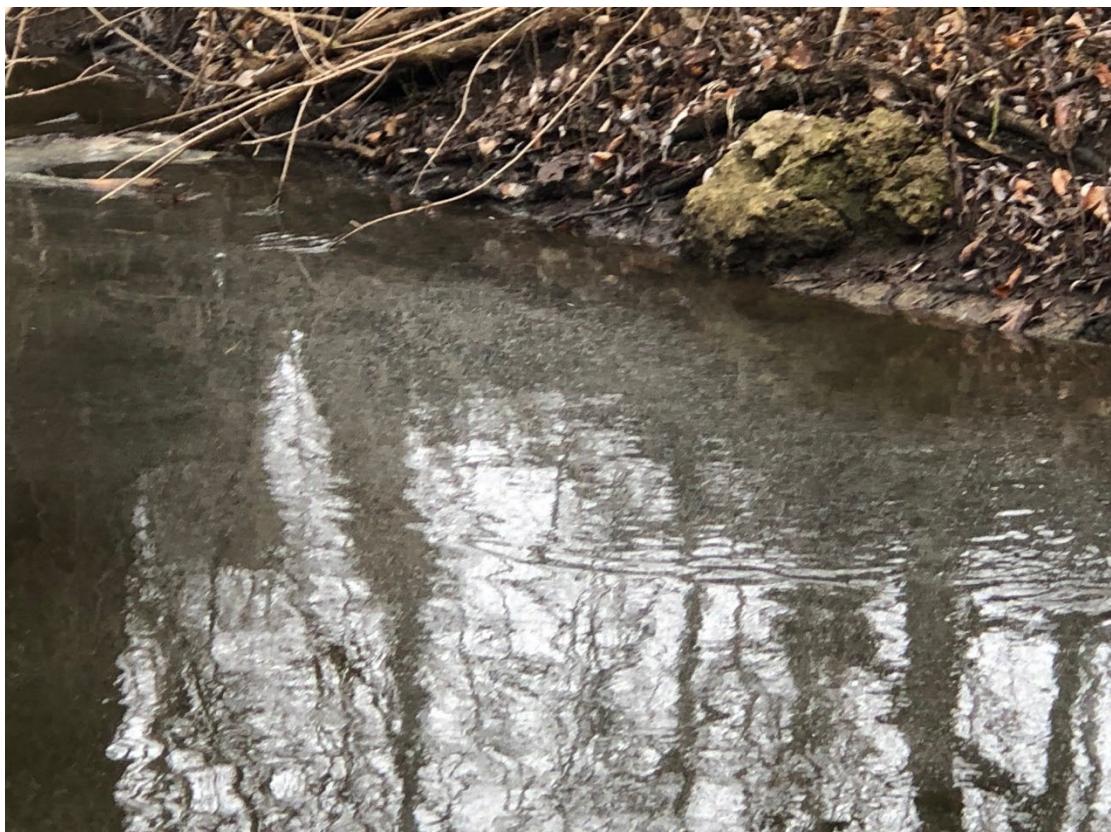
Figure 2a. Oil sheen on Letts Creek on 1/20/23, apparently originating from Chelsea Milling.

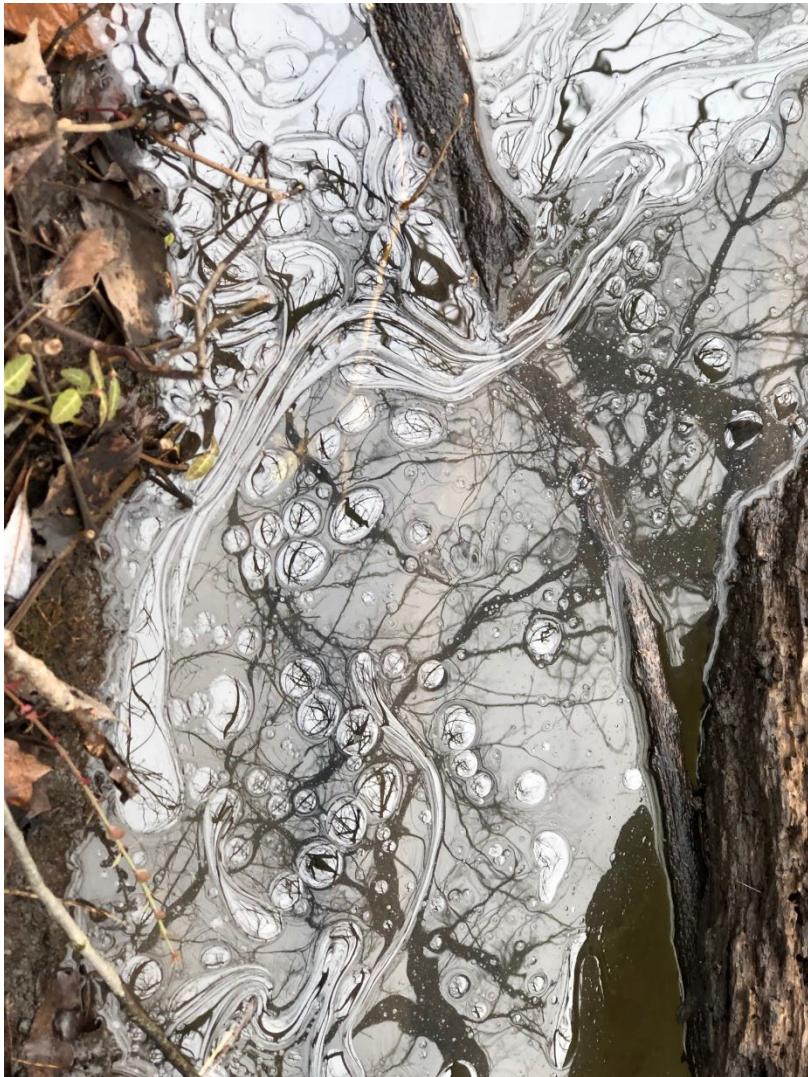
Figure 2b. Closeup of oil sheen on Letts Creek on 1/20/23, apparently originating from Chelsea Milling. This was a corn oil spill in the parking lot.
